DOT/FAA/CT-91/2

FAA Technical Center  
Atlantic City International Airport  
N.J. 08405

# Development and Growth of Inaccessible Aircraft Fires Under Inflight Airflow Conditions

Final Report

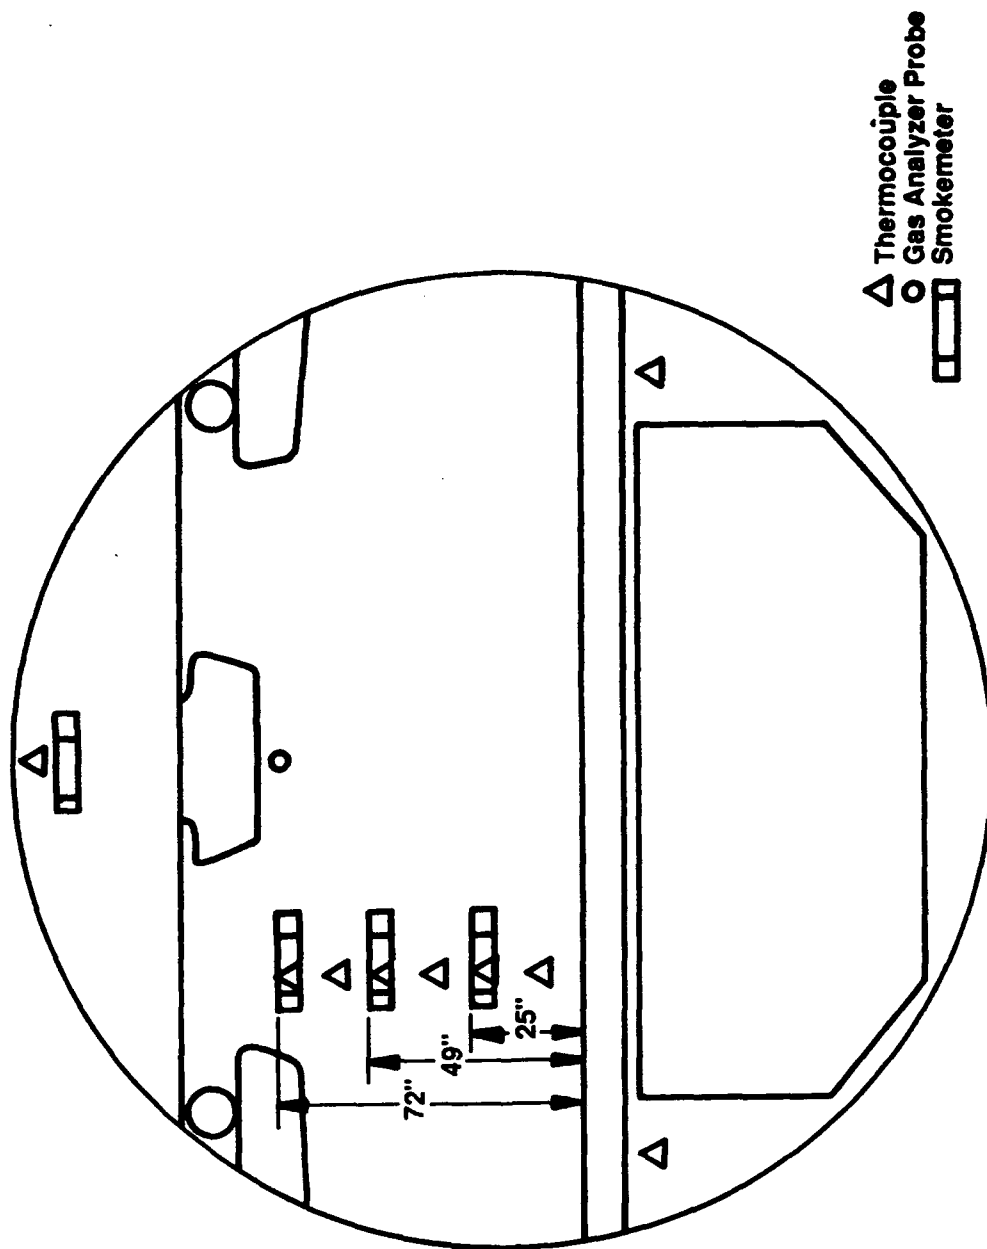
FIGURE 1. TEST ARTICLE INSTRUMENTATION—TOP VIEW

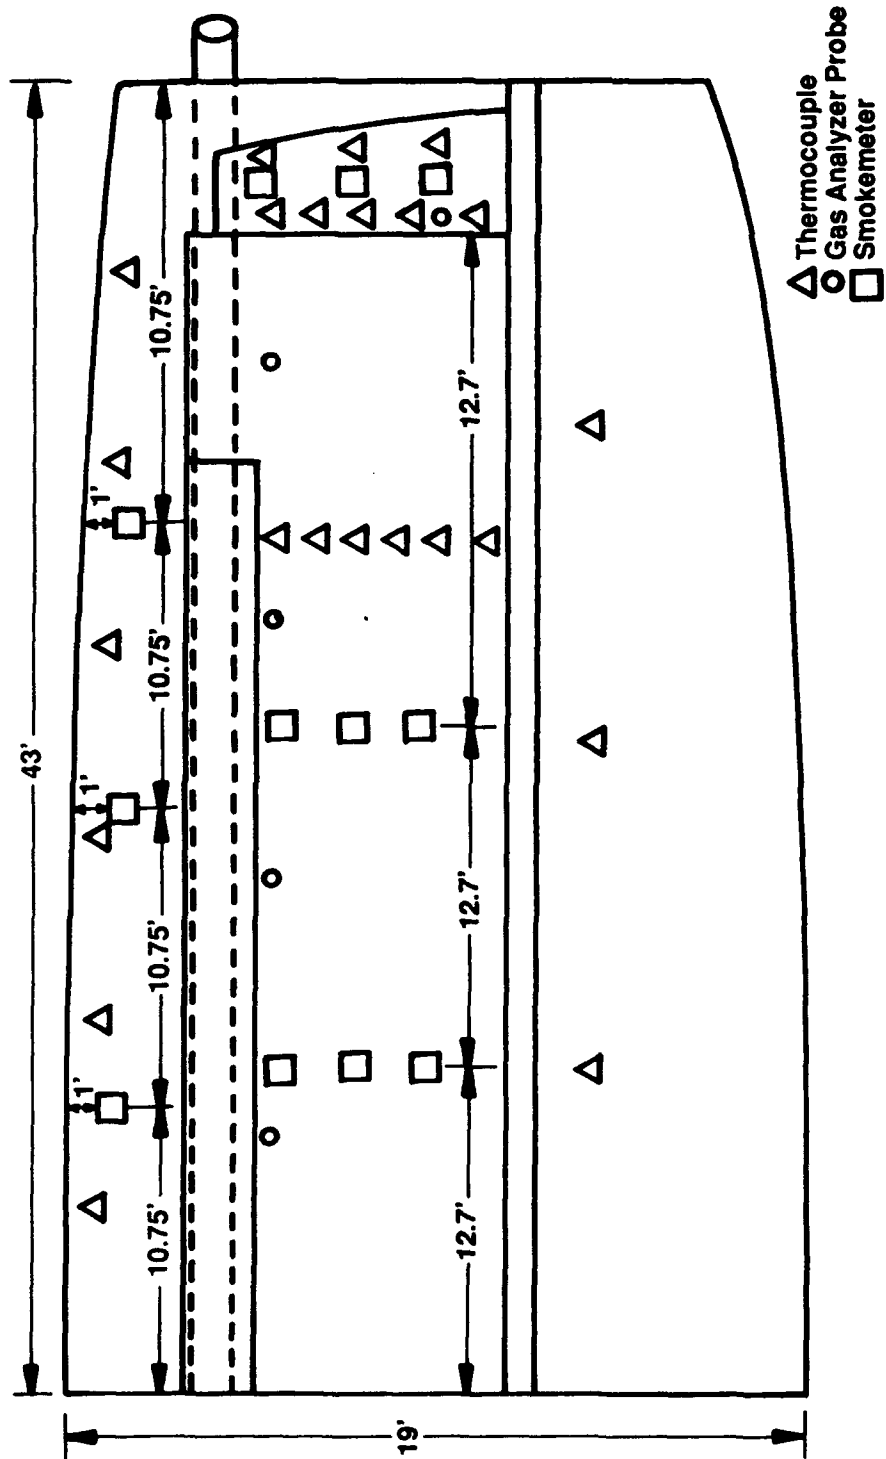
FIGURE 2. TEST ARTICLE INSTRUMENTATION--SIDE VIEW

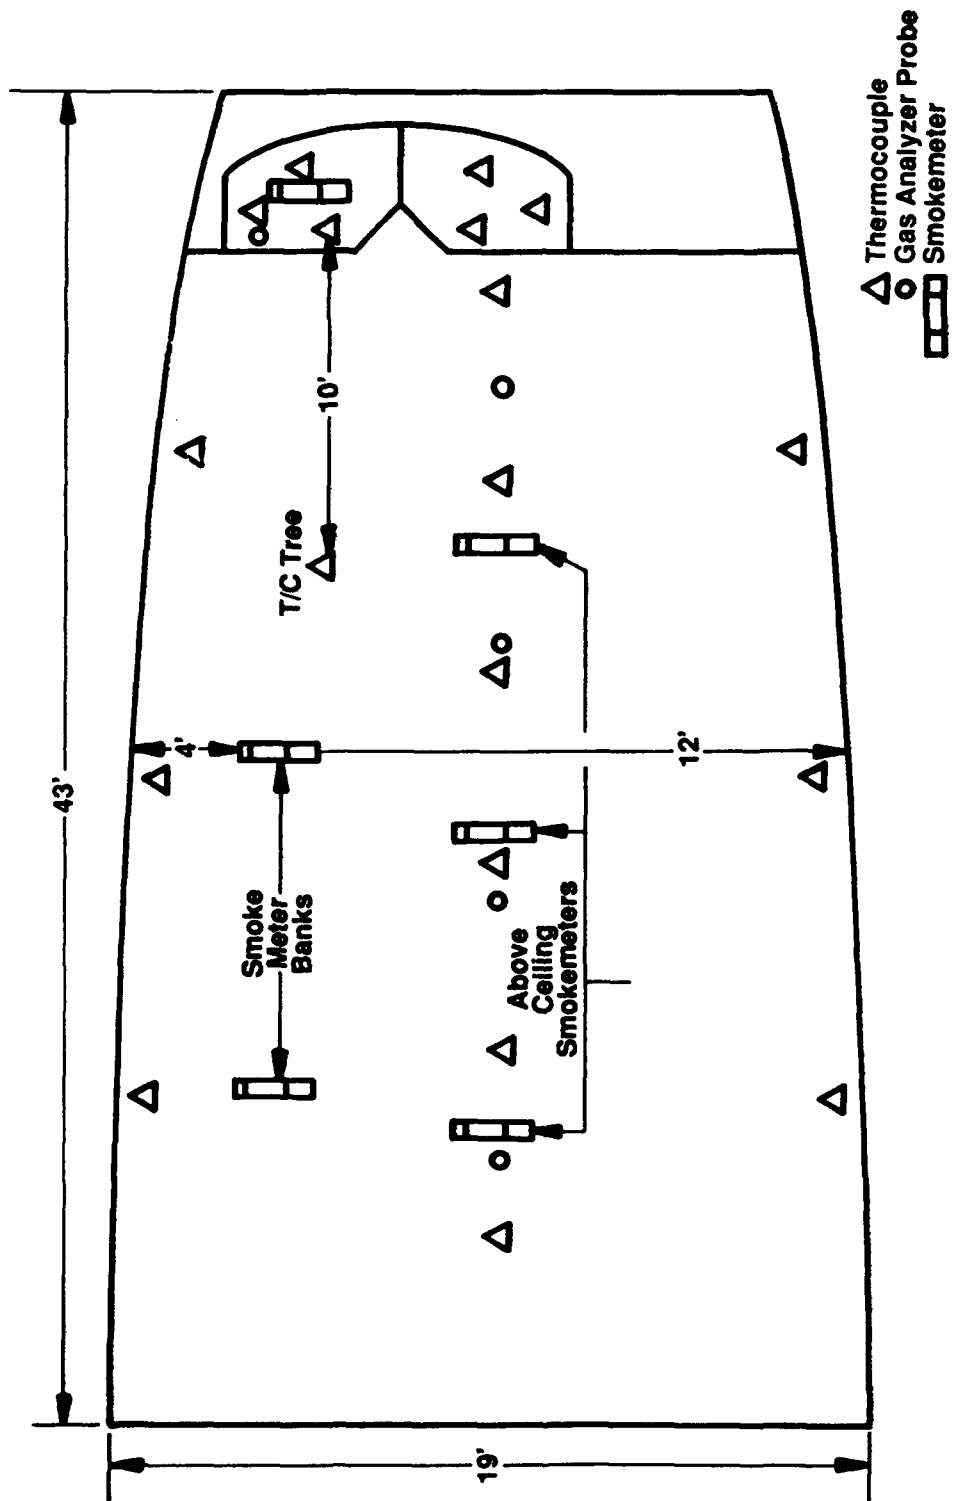
FIGURE 3. TEST ARTICLE INSTRUMENTATION--END VIEW

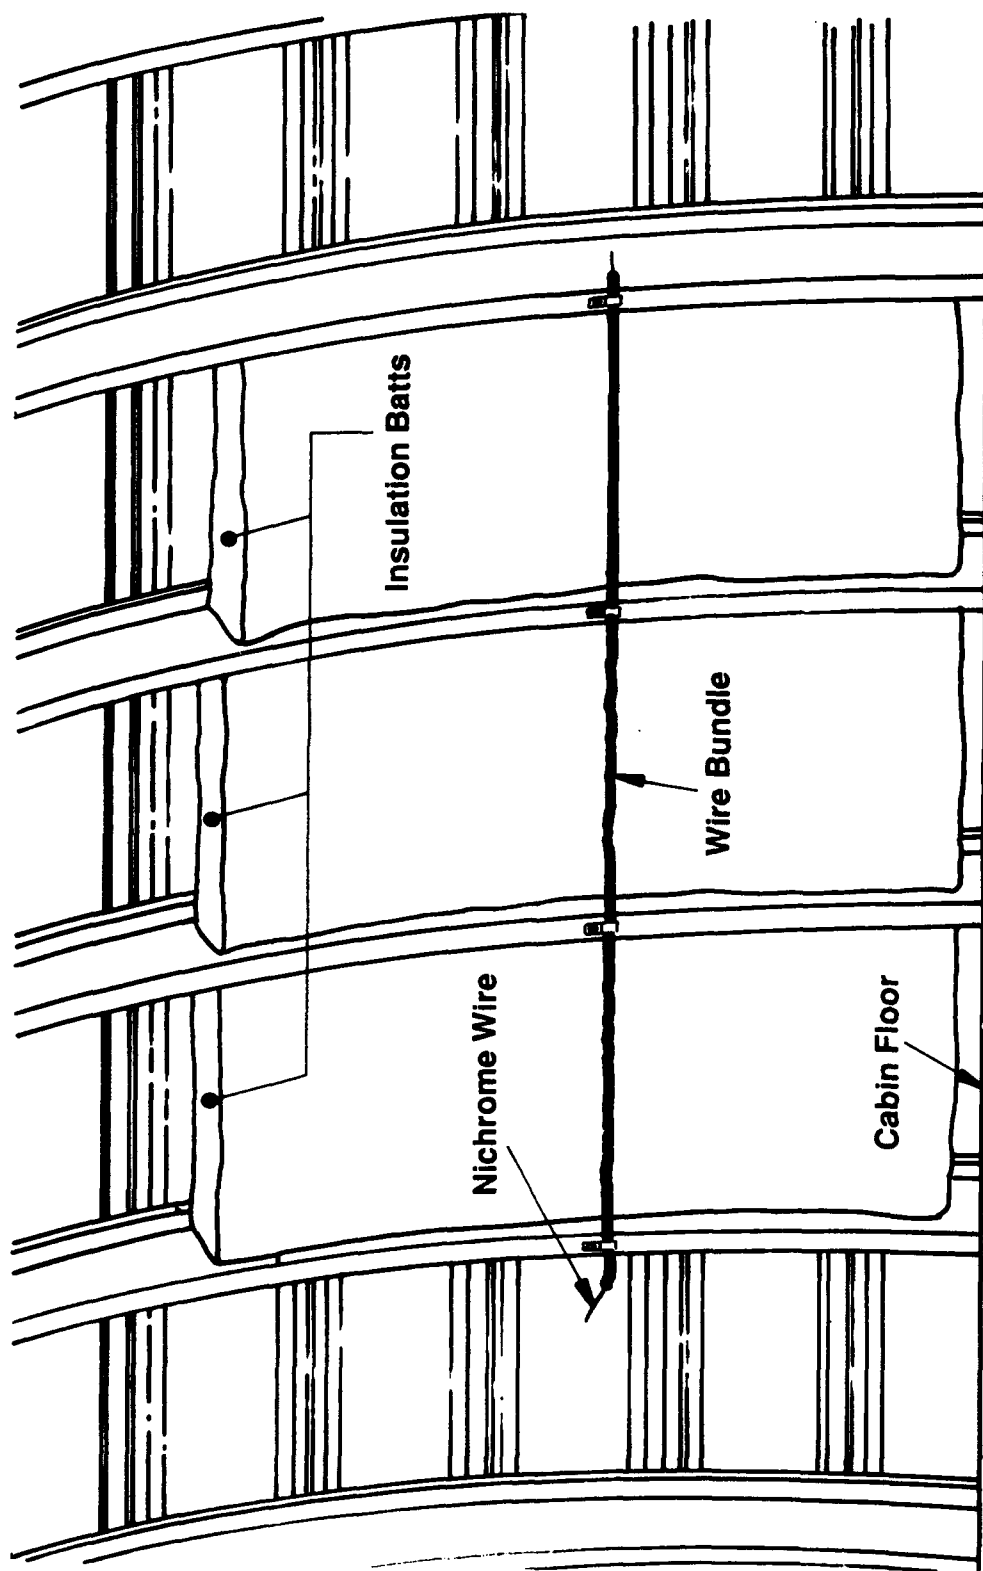
FIGURE 4. OVERHEATED WIRE BUNDLE

In this scenario a 3-foot section of a wire bundle with a length of nichrome wire added to the bundle was attached to the test article between the lavatory wall and the aircraft skin. Several fiberglass insulation batts were placed between the wire bundle and the outside skin as in figure 4. Current was passed through the nichrome wire to heat it and the wire bundle. Five different types of Orcon Corporation insulation covers were tested in this scenario. They were An-22 aluminized Tedlar<sup>TM</sup>, AN-19 aluminized Tedlar, AN-4C aluminized Tedlar, KN-80 polyimide Kapton<sup>TM</sup>, and AN-26 polyester Mylar<sup>TM</sup>. All test fires self-extinguished. The aluminized Tedlar and polyester Mylar coverings melted away from the wire bundle and were slightly burned in several areas. The polyimide Kapton covering only melted where it was in direct contact with the burnt wire bundle but did not burn. The smoke detectors did not alarm during any of these tests, and the smoke meters in the cabin did not measure any reduction in light transmission. Smoke and a strong burning smell were present in the test cell following these tests, but there was little or no smell inside the test article. The cabin ventilation system carried the smoke and fumes into the cheek area and then out the outflow valve into the test cell.

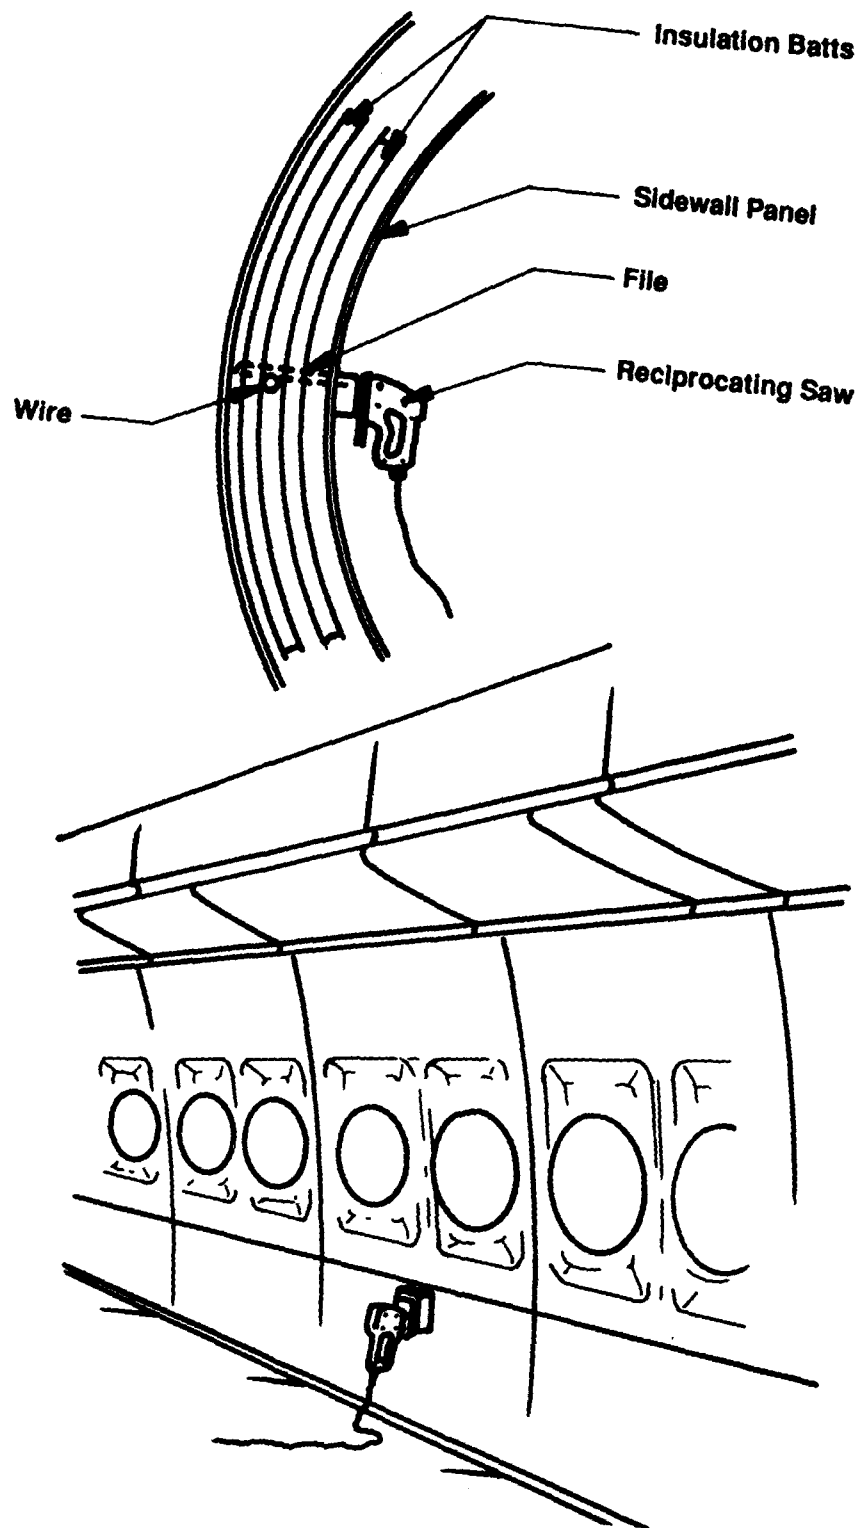
FIGURE 5. CHAFED WIRE BUNDLE BEHIND SIDEWALL

This scenario simulated a short in a bundle of Kapton insulated wire caused by chafing and the subsequent dry arc tracking that occurs when the circuit breakers are reset. Kapton is a highly thermally resistant material and is the most common aircraft wiring insulation. However, Kapton has a greater propensity for arc tracking than other types of wiring insulation, and it produces the most intense arc should arc tracking occur (references 1 and 2). A bundle of Kapton insulated wire was placed behind a cabin sidewall panel with a fiberglass insulation batt (with an aluminized Tedlar covering) between the wire bundle and the aircraft skin and another batt between the wire bundle and the sidewall panel. A reciprocating saw with a small file in place of the blade was attached to the sidewall panel and used to chafe the wire bundle. Figure 5 shows the configuration for this test scenario. The wire bundle consisted of 7 wires. Two wires were connected to each phase of a 220-volt, three-phase power supply with the seventh wire connected to ground. Each of the hot wires were protected by a 10-amp aircraft type circuit breaker. The test procedure was to energize the wire bundle and then chafe it with the saw until an arc occurred and a circuit breaker tripped. The breaker was reset which usually resulted in an additional arc and tracking to another wire in the bundle. The breakers were continually reset until arcing no longer occurred. The aluminized Tedlar insulation cover melted and burned away from the area of arcing and then quickly self-extinguished in tests 7, 9, 10 and 11. In those tests, the smoke detectors in the lavatory did not alarm and the smoke meters in the cabin and above the cabin ceiling recorded negligible levels of reduction in light transmission. In test 8, the arcing ignited the insulation cover which burned up to the bottom of the window and then self-extinguished. The decorative coating on the cabin side of the aluminum sidewall panel started to melt and peel away. Both of the lavatory smoke detectors alarmed at 11 minutes 34 seconds into the test. The lowest light transmission level measured in the cabin was 92 percent. This was measured by the smoke meter 72 inches from the floor in mid cabin. There was a negligible increase in cabin temperature and gas (CO, CO<sub>2</sub>) levels.

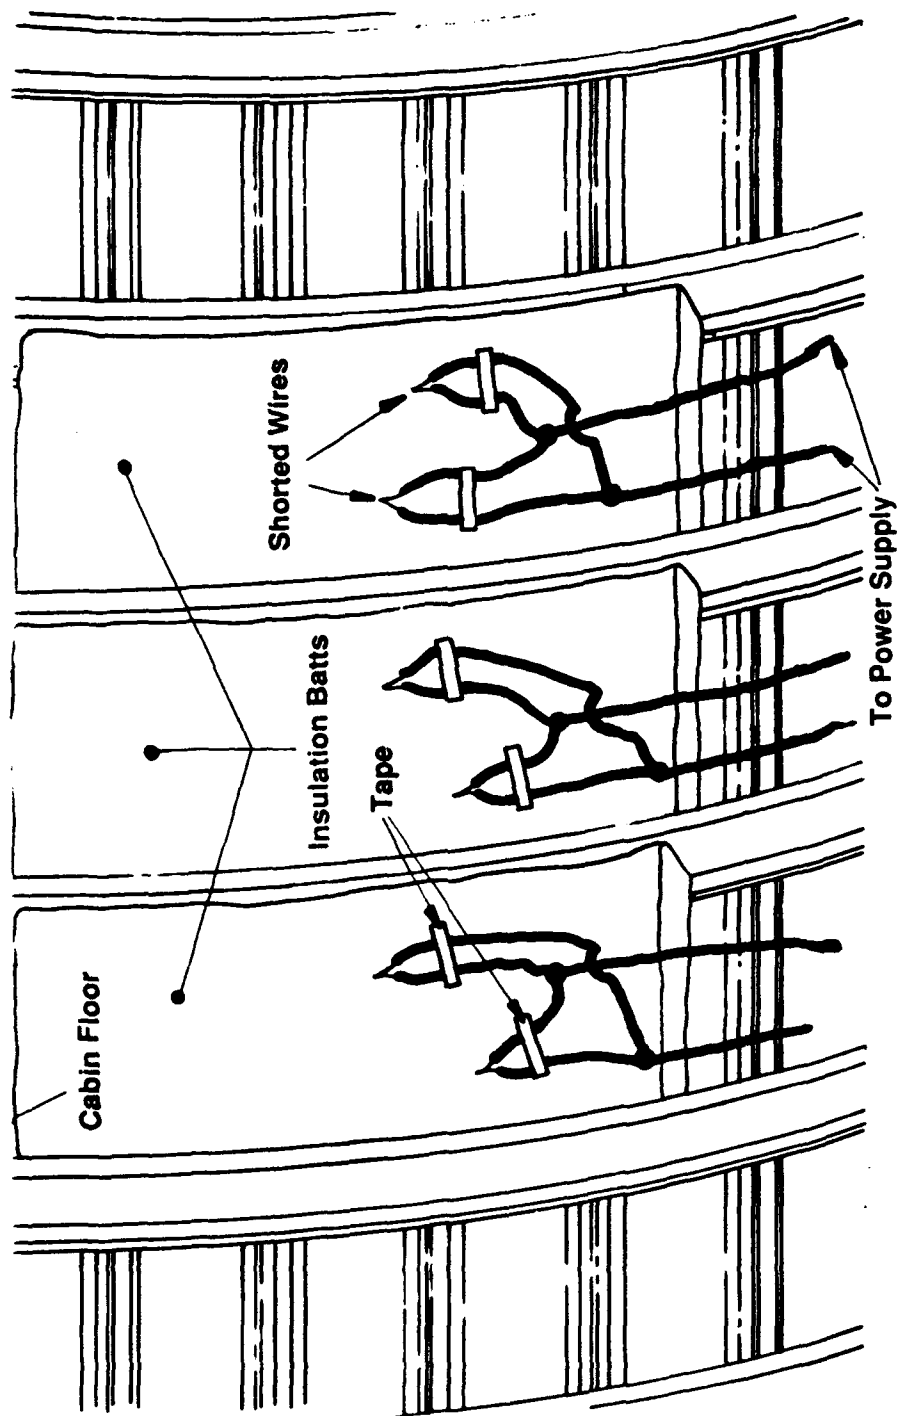
FIGURE 6. ARCING WIRES IN CHEEK AREA

This scenario simulated an arcing wire against an insulation batt in the cheek area. Fiberglass insulation with aluminized Tedlar covering was placed against the aircraft skin in the cheek area from the bottom of the cargo sidewall to the bottom of the cabin floor. Wires connected to a 220-volt, three-phase power supply were taped against the insulation batts and shorted together. Figure 6 shows the configuration for this test scenario. Tests 12, 13, and 16 used uncontaminated insulation covers. In these tests the arcs burned holes through the covers and the fiberglass insulation. The aluminized Tedlar covers were ignited by the arc, and small flames continued to burn for several minutes before self-extinguishing. Smoke detectors in the lavatory did not alarm, and smoke meters in the cabin measured only negligible smoke levels.

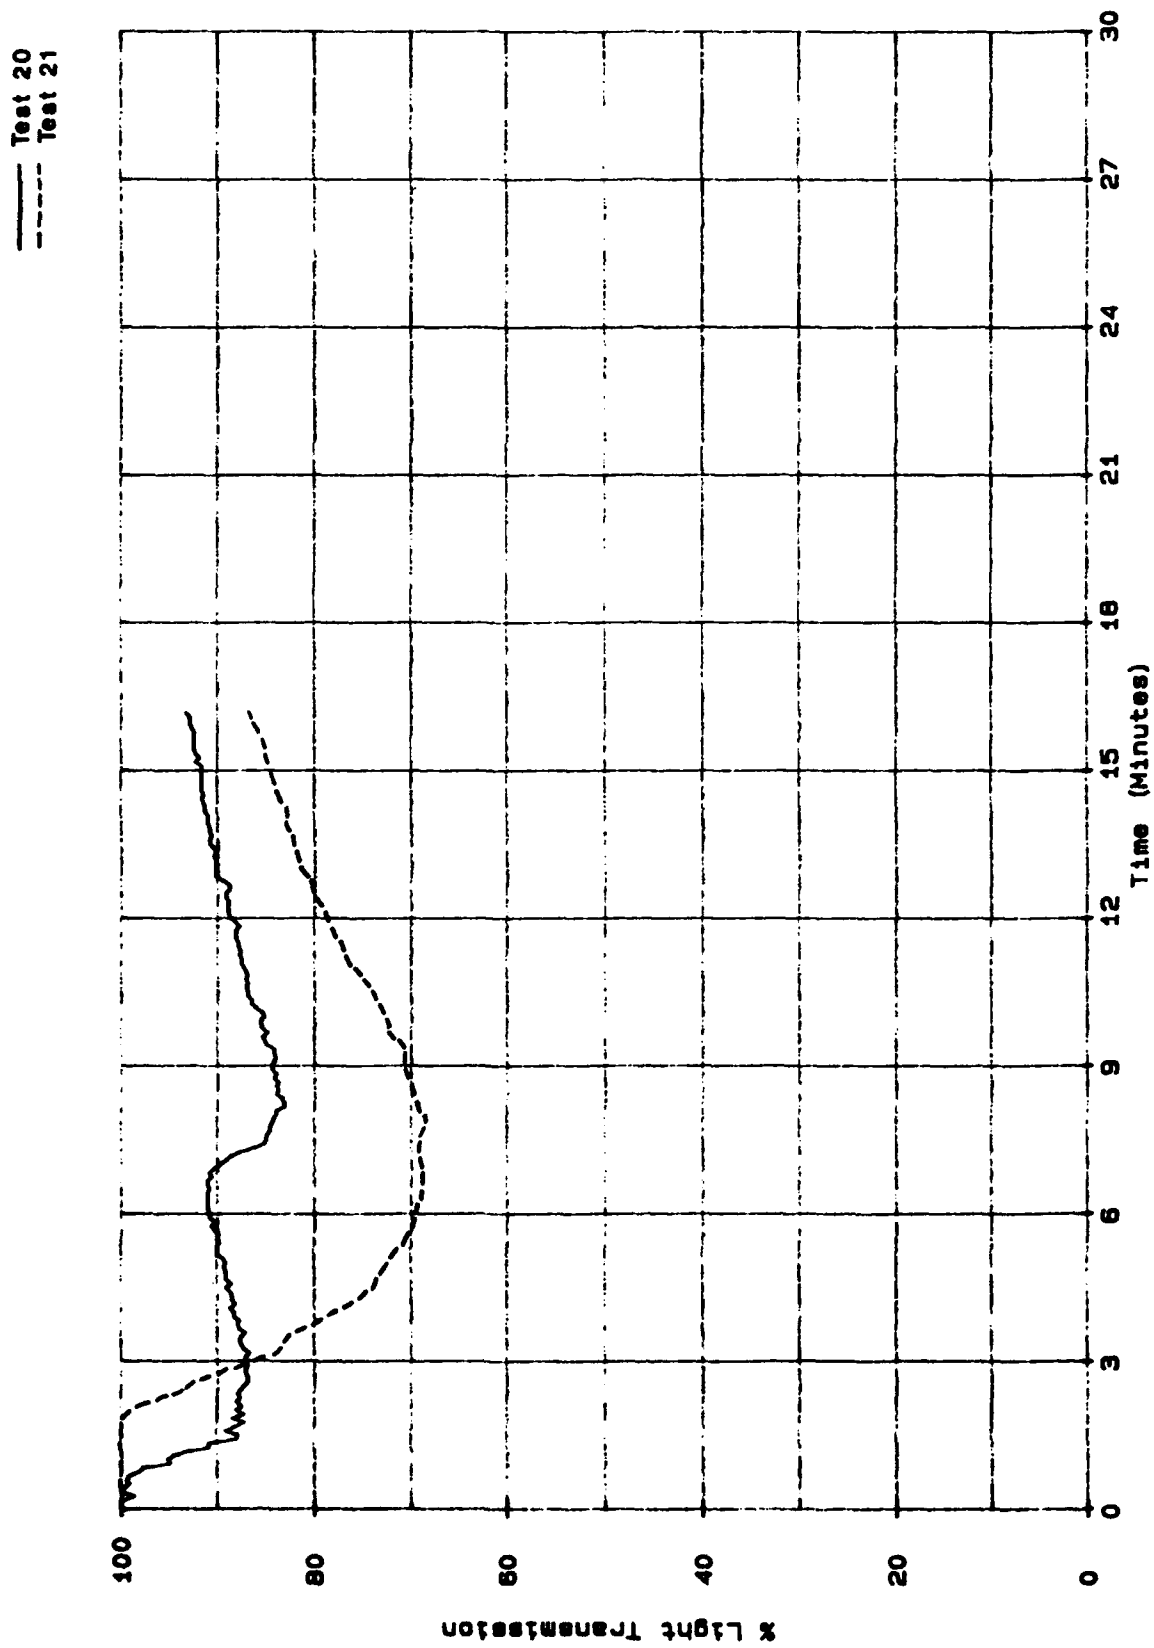
FIGURE 7. SMOKE LEVELS IN CABIN—TESTS 20 AND 21

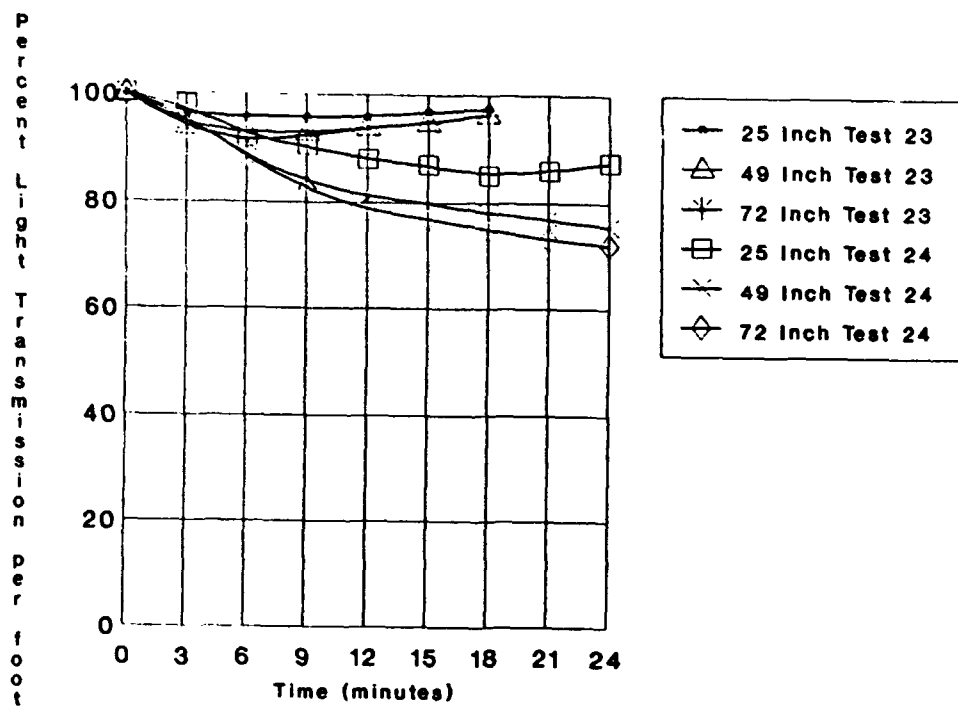
•Ventilation turned off at 4:12 in test 24

FIGURE 8. MID CABIN SMOKE—TESTS 23 AND 24

Test 24 and 25 used the same initial conditions as test 23. In these tests however, the cabin ventilation system was turned off and the outflow valve was closed as soon as the first smoke detector alarmed. In both tests, the first smoke detector to alarm was the photoelectric detector under the sink in the lavatory. This occurred at 4:12 in test 24 and 4:00 in test 25. Figure 8 is a graph of the smoke meter data in the cabin for tests 23 and 24 and shows that ventilation shutoff increased cabin smoke levels.

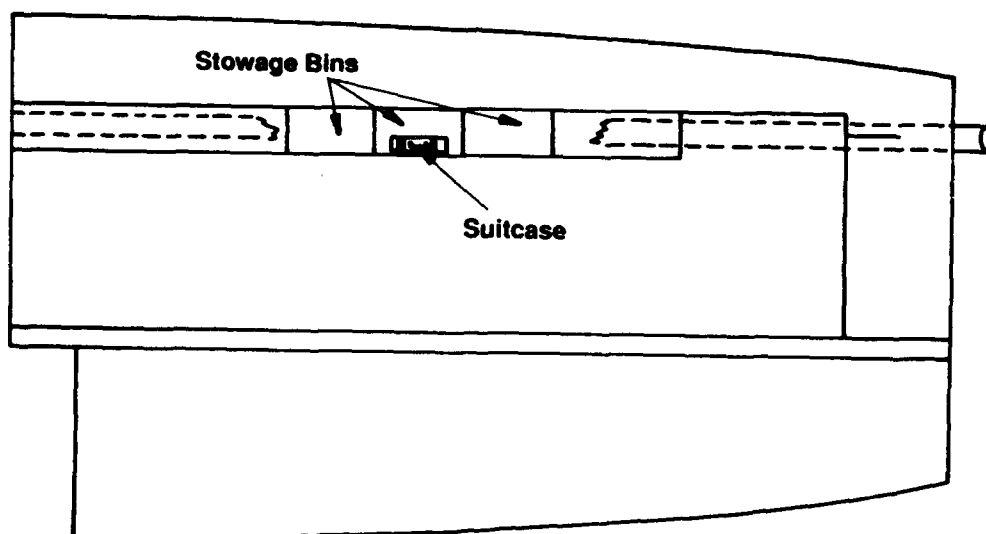
FIGURE 9. SUITCASE IGNITED IN STOWAGE BIN

In this scenario, a small suitcase was filled with rags and placed in a overhead stowage bin. Fiberglass insulation with aluminized Tedlar covering was installed between the stowage bin and the aircraft skin. A small quantity of alcohol was poured onto the rags, and the suitcase was ignited with nichrome wire. Figure 9 shows the configuration for these tests. In both tests, the top of the stow bin was burning within 1 minute of the start of the test. The fire completely destroyed the stow bin that the suitcase was in and damaged the bins on either side in both tests. In both tests, the thermocouple in the front of the cabin at the 6-foot level recorded a temperature rise of approximately 30 °F during the

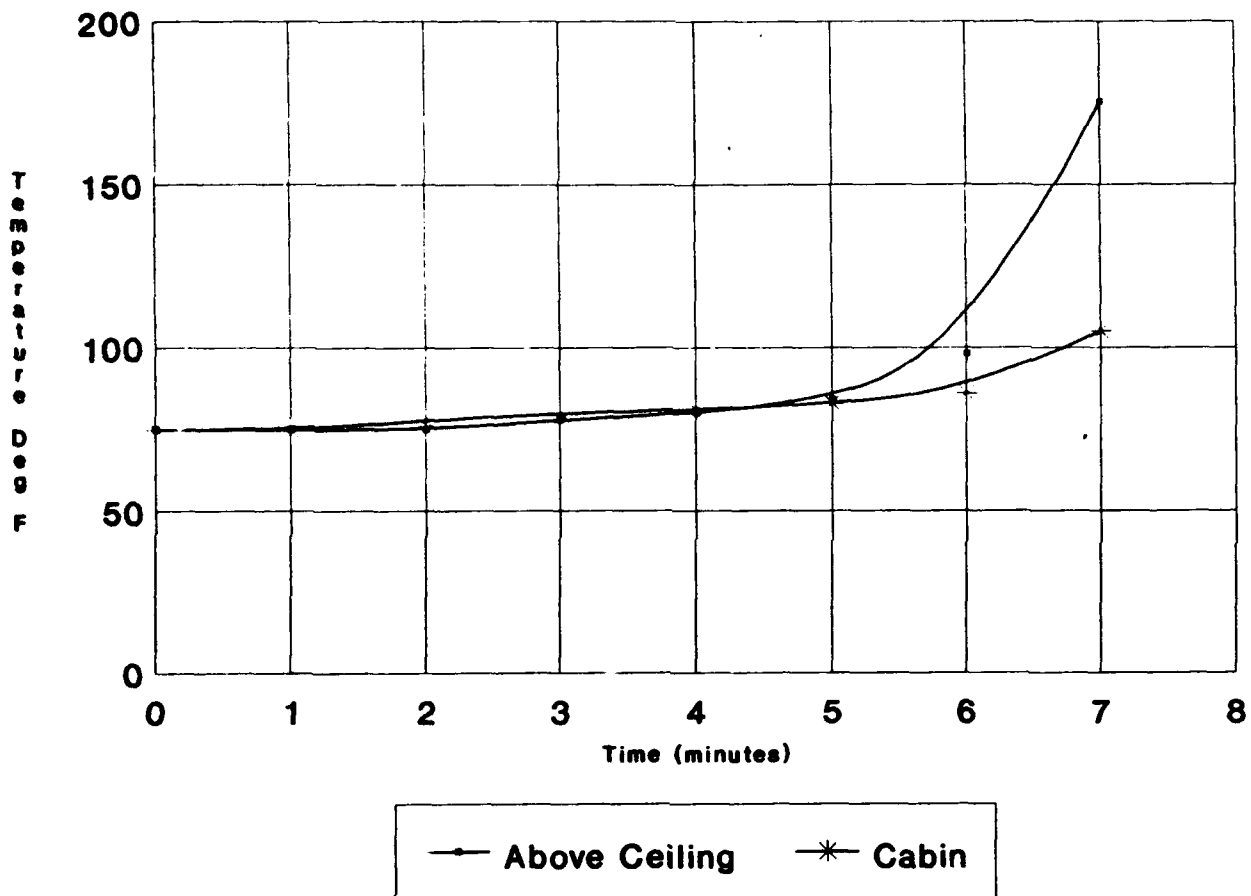
FIGURE 10. TEMPERATURES—TEST 30

test, and the maximum temperature measured by the thermocouples above the cabin ceiling was 175 °F. Figure 10 shows the temperature above the cabin ceiling and at the 6-foot level in the cabin for test 30. Light transmission was reduced to approximately 45 percent in mid cabin and to near zero above the cabin ceiling in both tests. Smoke levels in mid cabin for test 29 are shown in figure 11. The stowage bins used in this scenario were tested in the Ohio State University rate of heat release calorimeter. This is the flammability requirement, described in FAR 25.853, Appendix F, Part IV, for ceiling and sidewall panels, partitions, galleys, and overhead stowage bins that became effective in August of 1988. Although these stowage bins were removed from service prior to August 1988 and therefore were not required to pass this new flammability test, they did meet the criteria that were in effect from August 1988 to August 1990. The 2-minute total heat release was 86.34 kW\*min/m<sup>2</sup> and the peak heat release rate was 73.44 kW/m<sup>2</sup>. The criteria in effect from August 1988 to August 1990 were a maximum total heat release of 100 kW\*min/m<sup>2</sup> and a maximum peak heat release rate of 100 kW/m<sup>2</sup>. After August of 1990, the criteria became more stringent; i.e., a maximum total heat release of 65 and a maximum peak heat release rate of 65.

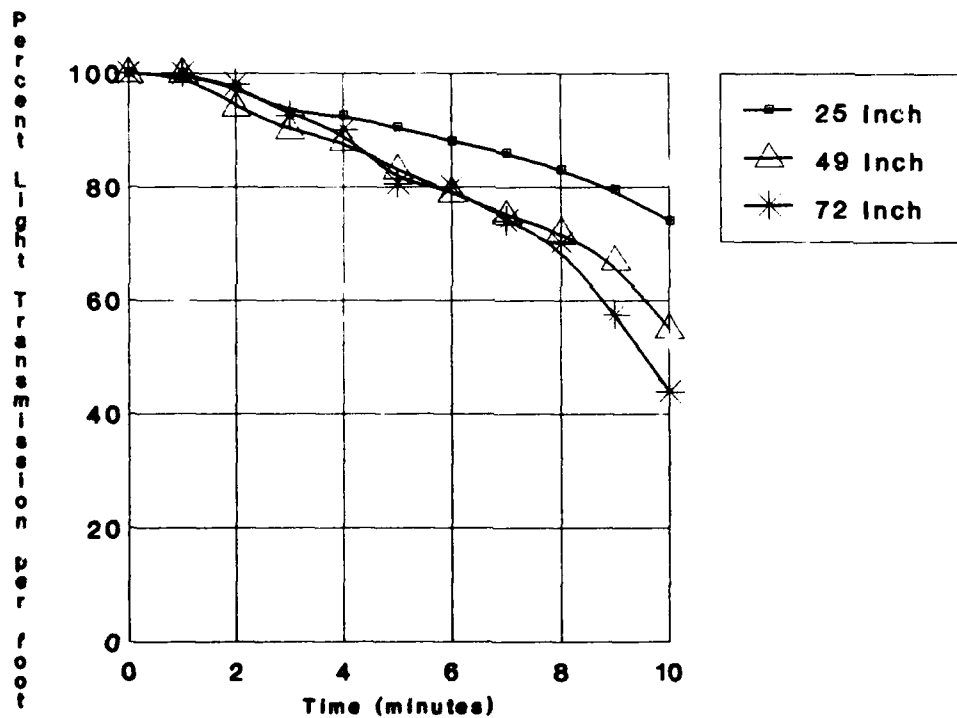
FIGURE 11. MID CABIN SMOKE—TEST 29

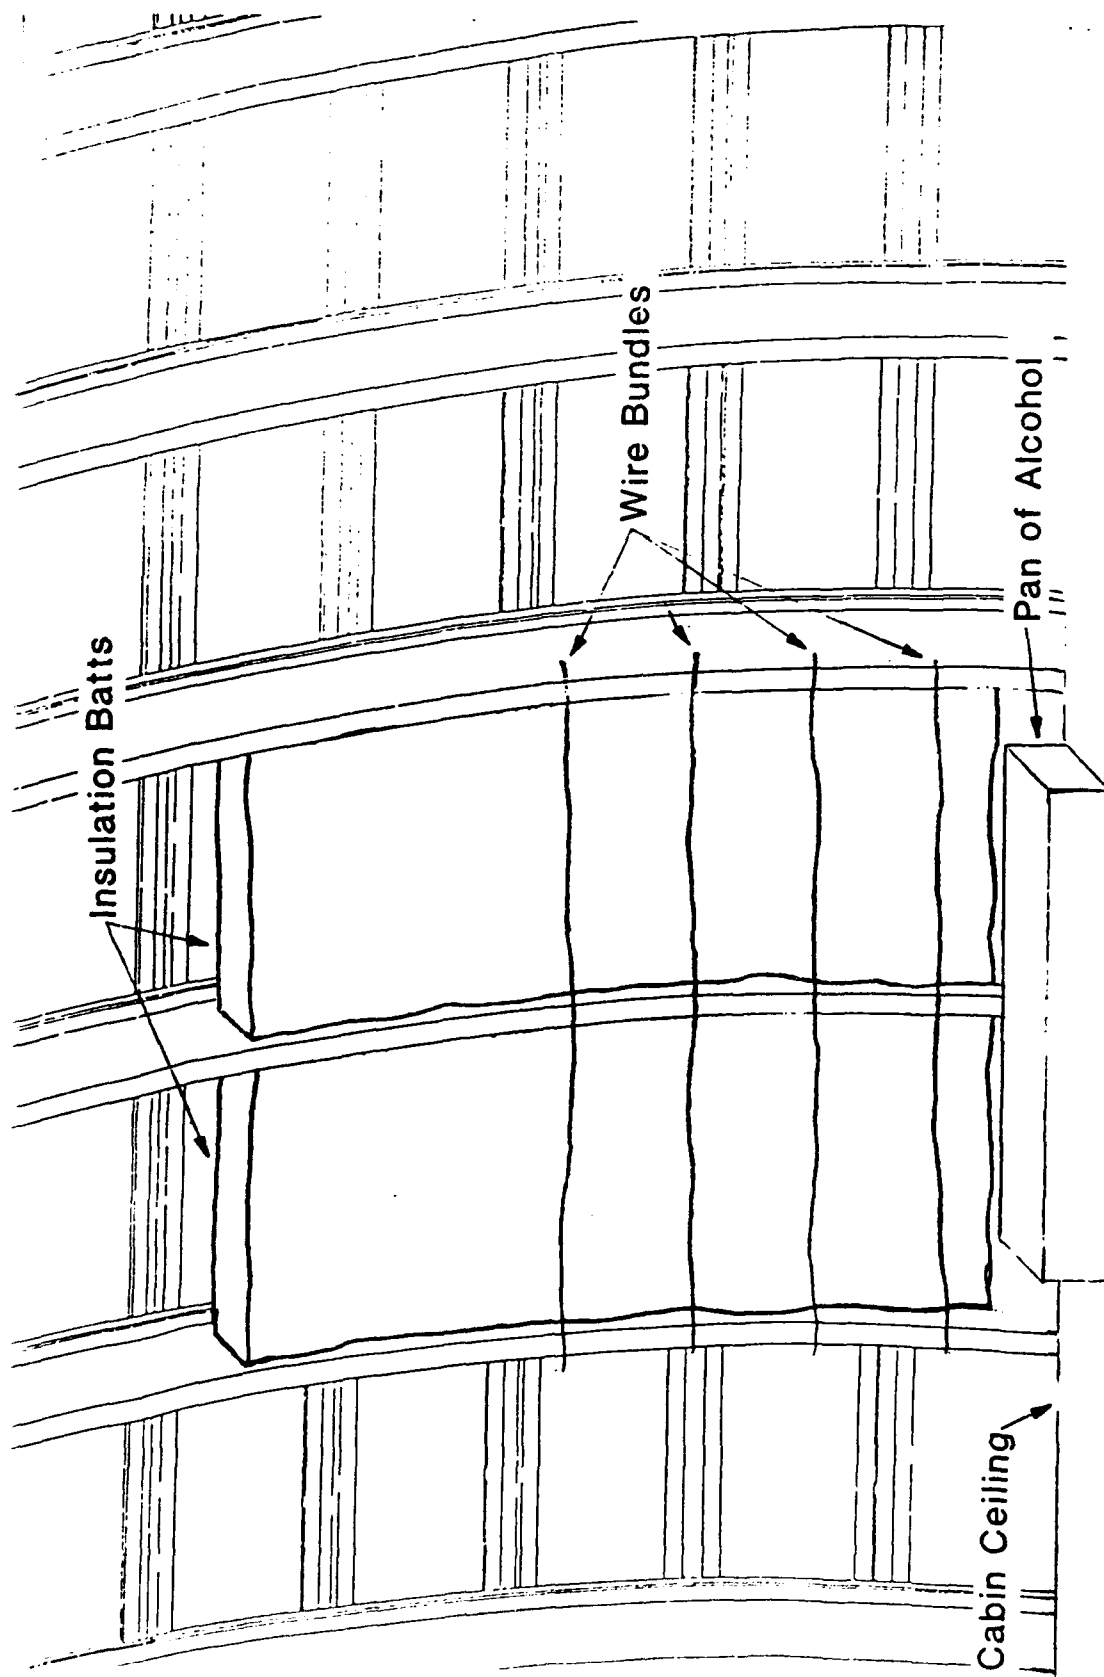
FIGURE 12. WIRE AND INSULATION IGNITED ABOVE CABIN CEILING

This scenario exposed three different combinations of wire bundles and insulation batts to a pan of burning alcohol above the cabin ceiling. The purpose of these tests was to evaluate the hazards introduced into the cabin from a relatively small amount of burning material. The three combinations of materials were Kapton insulated wire bundles against Kapton covered fiberglass insulation (test 31); polyvinyl chloride (PVC)/nylon insulated wire bundles against aluminized Tedlar covered fiberglass insulation (test 32); and Tefzel (ethylene tetra fluoro-ethylene) insulated wire bundles against aluminized Tedlar covered fiberglass insulation (test 33). Four wire bundles of twenty 22-gauge wires each were used in each test. Two insulation batts were installed against the aircraft outer skin, and the wire bundles were installed against the insulation batts. A pan of alcohol was positioned at the bottom of the insulation batts just above the cabin ceiling. Figure 12 shows the test configuration for this scenario.

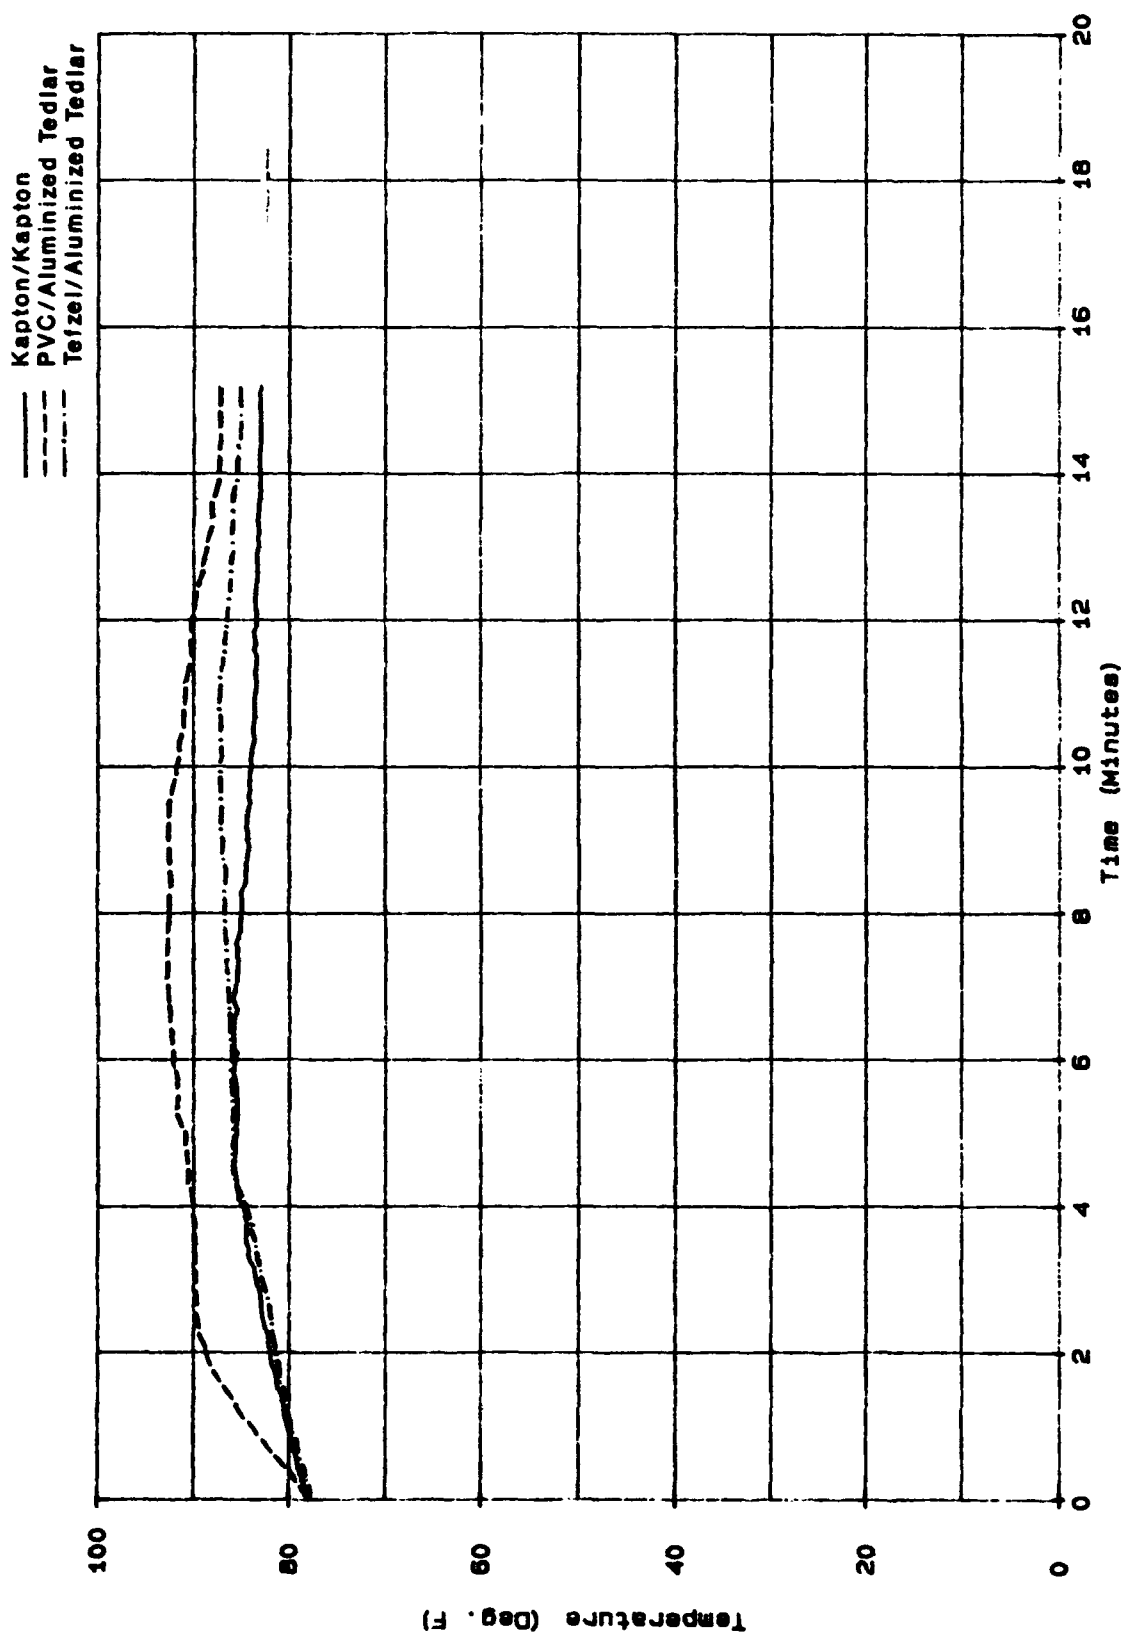
FIGURE 13. ABOVE CEILING AVERAGE TEMPERATURE--TESTS 31, 32, AND 33

Test 32, with PVC wire and aluminized Tedlar insulation batts, produced significantly more smoke and heat than tests 31 and 33. Figure 13 shows the average temperature above the cabin ceiling for the three tests. The temperature is the average of the six thermocouples in the 950-cubic-foot space above the ceiling. Figures 14 and 15 show the average smoke levels for the three smoke meters above the ceiling and the three smoke meters in mid cabin. It can be seen from these graphs that the main source of smoke and heat in test 32 was from the PVC wire insulation, since test 33 used the same aluminized Tedlar insulation covering as test 32 but produced much less smoke and heat. A PVC/nylon wire insulation will not pass the current flammability test for aircraft wiring which was imposed in 1972. However, it was installed on some aircraft manufactured prior to that date, many of which are still in service. Kapton and Tefzel insulated wires do pass the current flammability test. Figures 16, 17, and 18 show the wire bundles and insulation before and after each of the three tests.

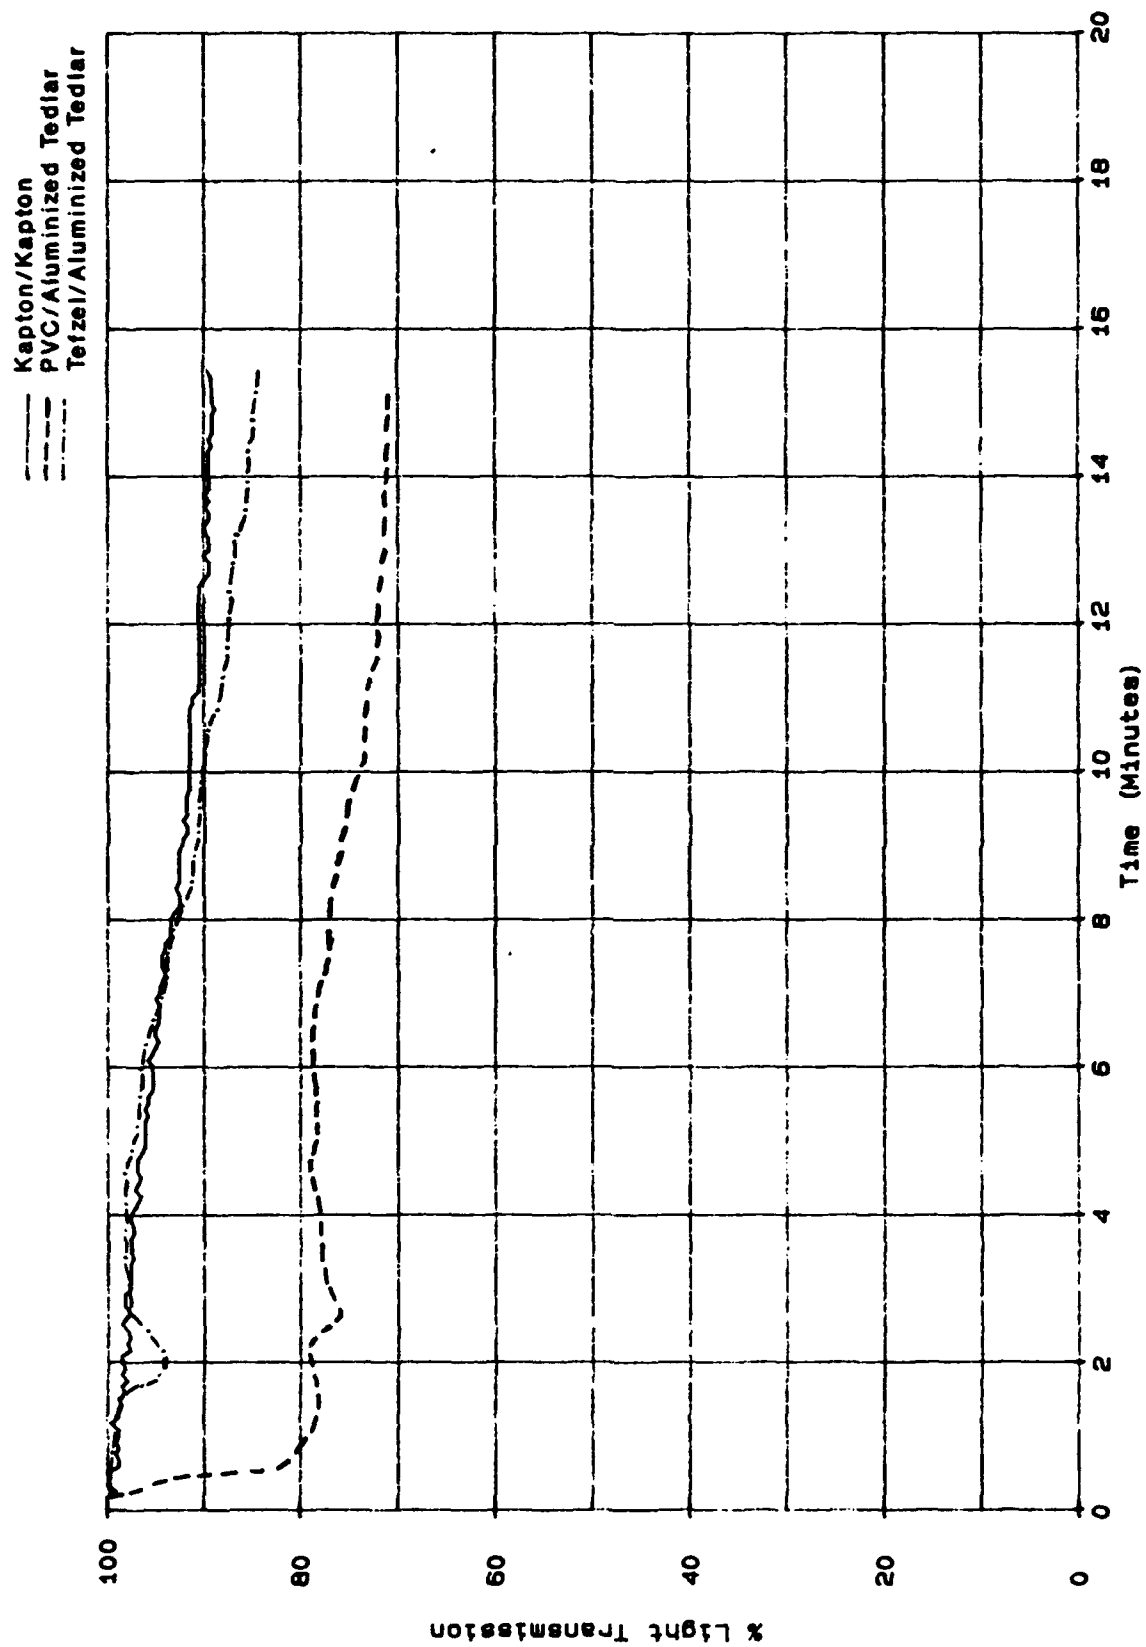
FIGURE 14. ABOVE CEILING AVERAGE SMOKE LEVEL--TESTS 31, 32, AND 33
